**Flood Control Project Maintenance  
Levee Inspections**  
**LMA District Cover Sheet**  
**Spring 2016 Levee Inspection Results**

**Reclamation District No. 0556 Upper Andrus**

**Spring 2016 Levee Inspection Results**

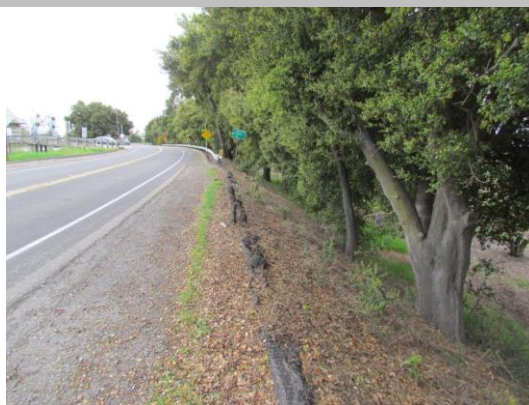
Photo 1 of 1 : SP\_2016\_RD0556\_18\_25\_20160512\_00053.jpg

RD 556 Looking downstream from the landside slope levee mile 0.17-2.59

LM Start	0.33	Rating **	M	Issue No.	31
LM End	0.59	Issue Type +	Ma	Location *	LS
Category	Earthen Levee			GPS Latitude/Longitude	
				Start	End
Item	Trim / Thin Trees			38.234682 °	38.231795 °
				-121.519282 °	-121.522350 °
DWR ID	DWR_RD0556_01_s_2016_31				
Comment Code					
T1 : Trim trees to at least five feet above ground level.					
Inspector Comment

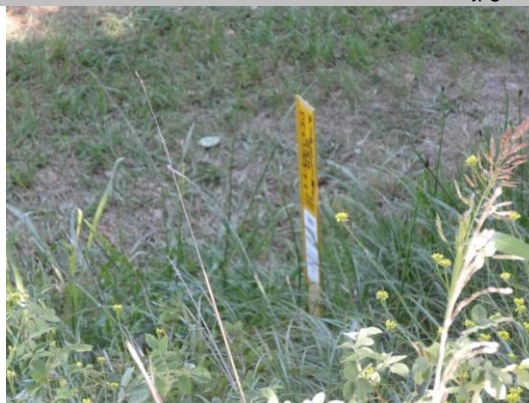
Photo 1 of 2 : UCIP\_SP\_2016\_45564\_74151.jpg

LM Start	0.44	Rating **	M	Issue No.	383
LM End	0.44	Issue Type +	En	Location *	LS
Category	Supplemental			GPS Latitude/Longitude	
				Start	End
Item	DWR UCIP Field Study			38.233537 °	38.233537 °
				-121.520483 °	-121.520483 °
DWR ID					
Comment Code					
Inspector Comment					
FS_ID:45564					
DS_ID:20820					
EP_NO: 3448					
Repair Type: Non-Urgent					
Crossing Status: Indicator Found					
UCIP Comments: Dense vegetation inhibited visibility of gasline marker on WS. Need to contact owner to determine status of crossing.					
FIELD_STRUCT_DESC: 4-1/2-inch steel pipe gas line through levee, 4.0 feet below the crown. Location marker on waterward shoulder. (App. 3448-PG&E pipe not located 2/91). Cut in pavement visible at crossing.					
Gasline marker on LS and opposite bank at RD 263.					
FS Date: 5/27/2015

Gasline marker present on LS.

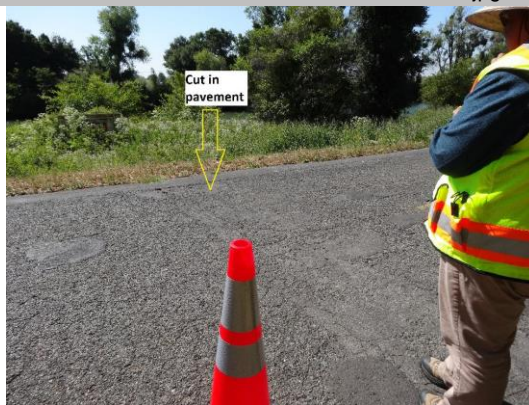
Photo 2 of 2 : UCIP\_SP\_2016\_45564\_74146.jpg

View of WS; cut in pavement in alignment with arrow and Olivia indicating location of crossing trench.

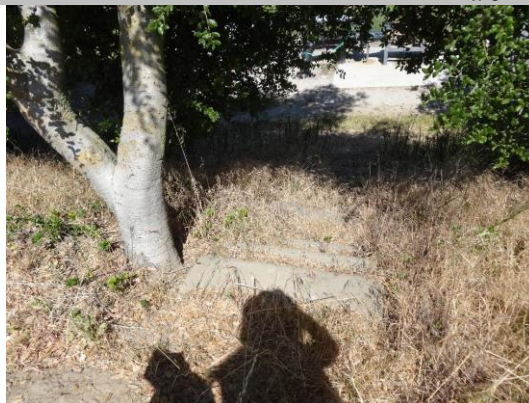
Photo 1 of 2 : UCIP\_SP\_2016\_45663\_74180.jpg

FS\_ID:45663  
DS\_ID:20821  
EP\_NO: 5548  
Repair Type: Non-Urgent  
Crossing Status: Found  
UCIP Comments: Dense vegetation prevents inspection of WS slope.  
FIELD\_STRUCT\_DESC: 12-inch steel pipe through levee, 5.0 feet below crown. 1-1/4-inch electrical conduit through the levee. Concrete steps on landward slope. Pump off landward toe. Cuts visible on pavement. (App. 5548).  
FS Date: 5/13/2015

Concrete steps on LS slope.

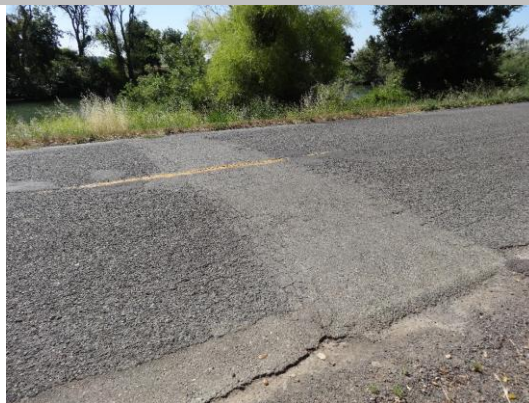
Photo 2 of 2 : UCIP\_SP\_2016\_45663\_74181.jpg

View of WS with cuts visible on pavement.

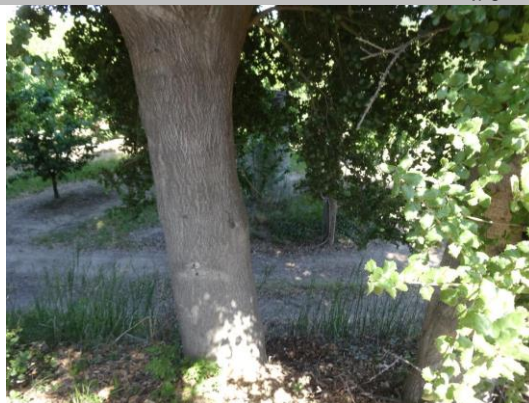
Photo 1 of 2 : UCIP\_SP\_2016\_45664\_74190.jpg

FS\_ID:45664  
DS\_ID:20826  
EP\_NO: 5548A  
Repair Type: Non-Urgent  
Crossing Status: Found  
UCIP Comments: Dense vegetation prevented inspection of WS slope.  
FIELD\_STRUCT\_DESC: 14-inch pipe through levee 5.0 feet below the crown. Pole with panel and standpipe on landward toe (5548A- Kay Dix Ranch 1986).  
FS Date: 5/27/2015

View of LS with standpipe visible behind tree.

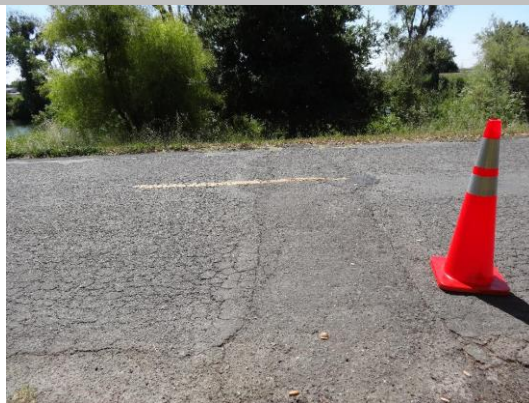
Photo 2 of 2 : UCIP\_SP\_2016\_45664\_74191.jpg

View of WS with cuts visible on pavement.

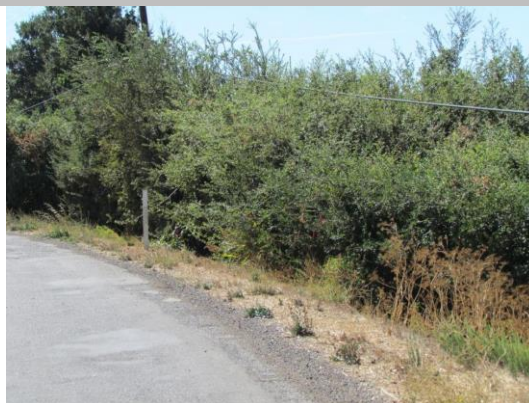
Photo 1 of 1 : SP\_2016\_RD0556\_18\_10\_20160223\_00003.jpg

Unsatisfactory woody tree growth on the landside shoulder and slope.

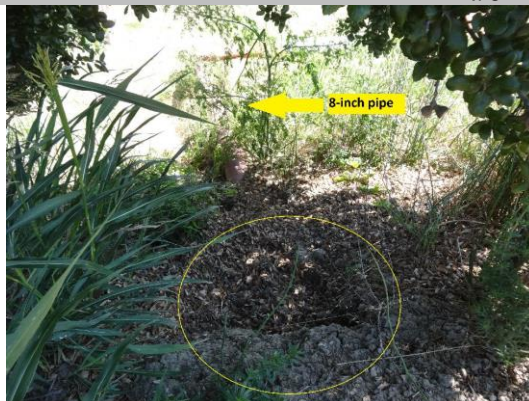
Photo 1 of 2 : UCIP\_SP\_2016\_46799\_74739.jpg

FS\_ID:46799  
DS\_ID:25106  
EP\_NO: N/A  
Repair Type: Non-Urgent  
Crossing Status: Found  
UCIP Comments: Possible erosion above pipe on LS needs attention.  
FIELD\_STRUCT\_DESC: 8-inch steel irrigation pipe unknown feet below crown visible on LS 6 ft away from 10-inch pipe. Post likely for protection of vent located off the crown on shoulder. Electric pole next to pipe on LS.  
FS Date: 5/27/2015

LS view: 8-inch pipe off LS slope with possible erosion above pipe (circled).

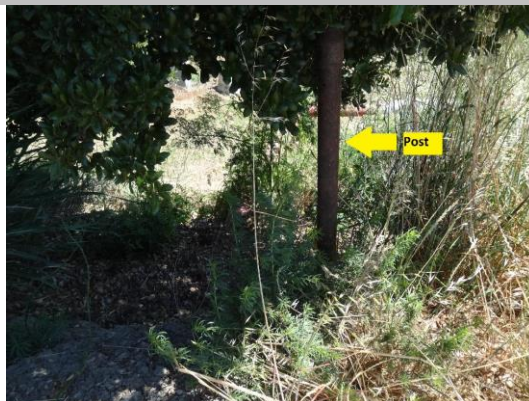
Photo 2 of 2 : UCIP\_SP\_2016\_46799\_74740.jpg

LS view: Post located above pipe on LS slope.

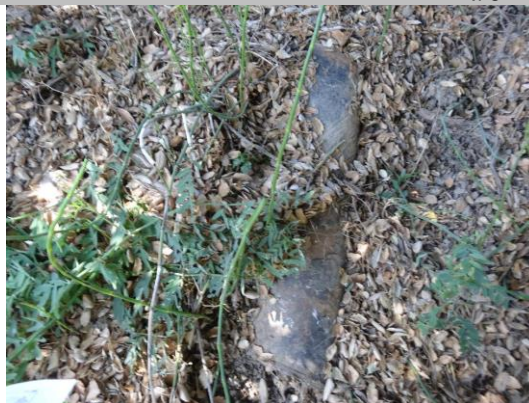
Photo 1 of 2 : UCIP\_SP\_2016\_45683\_74200.jpg

LM Start	1.17	Rating **	M	Issue No.	386
LM End	1.17	Issue Type +	En	Location *	LS
Category	Supplemental			GPS Latitude/Longitude	
				Start	End
Item	DWR UCIP Field Study			38.227568 °	38.227568 °
				-121.529489 °	-121.529489 °
DWR ID					
Comment Code					
Inspector Comment					
FS_ID:45683 DS_ID:20823 EP_NO: 11169 Repair Type: Non-Urgent Crossing Status: Found UCIP Comments: Appears abandoned in place and if so should be done so properly. Desnse vegetation on WS limits visibility. FIELD_STRUCT_DESC: 10-inch pipe through levee, 3.8 feet below crown. (Lower end of rock revetment)(ABO 11169 - Mealer and 4848). Abandoned in place. O&M Manual Sac 103, June 1954 FS Date: 5/27/2015

LS view of pipe appearing abandoned in place.

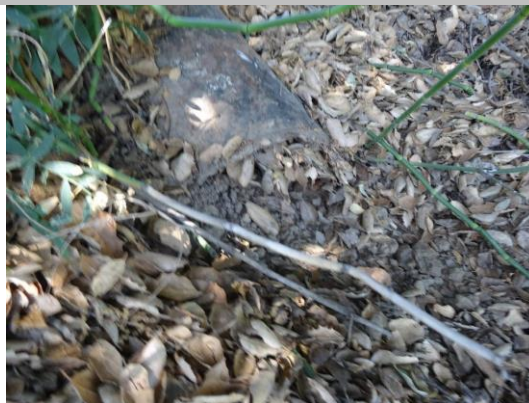
Photo 2 of 2 : UCIP\_SP\_2016\_45683\_74201.jpg

Closeup of abandoned pipe.

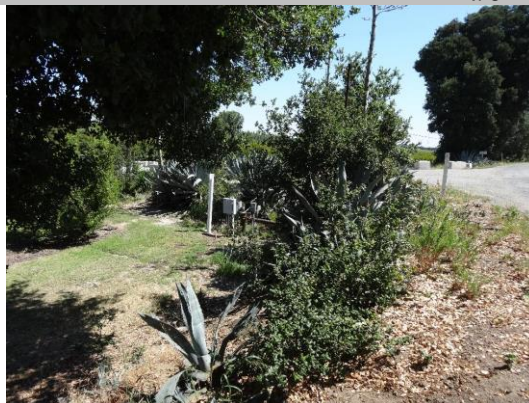
Photo 1 of 2 : UCIP\_SP\_2016\_45692\_74204.jpg

Comment Code					
Inspector Comment					
FS_ID:45692 DS_ID:20825 EP_NO: 13302 Repair Type: Non-Urgent Crossing Status: Found UCIP Comments: Seal beneath siphon breaker off LS toe leaking. Rodent activity near crown off LS shoulder. Need to contact owner about leaky seal. Dense vegetation prevented inspection of WS slope. FIELD_STRUCT_DESC: 6-inch steel pipe and 2-inch GI electrical conduit through levee 2 feet below crown; roadway with siphon valve on landward shoulder. Concrete stand and pump on landward toe; circuit box also. Cuts visible on pavement. 6-inch PVC standpipe adjacent to pipe off LS toe. (Kay Dix Ranch App. 13302). O&M Manual Sac 103, June 1954 FS Date: 5/27/2015

Pipe, standpipe, electrical box at LS toe. Pumphouse in bush behind electrical box.

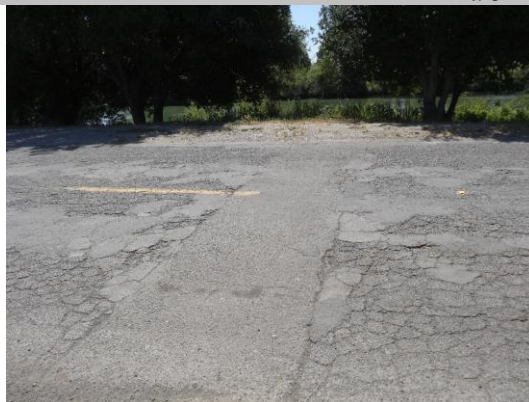
Photo 2 of 2 : UCIP\_SP\_2016\_45692\_74205.jpg

WS view and cuts visible on pavement.

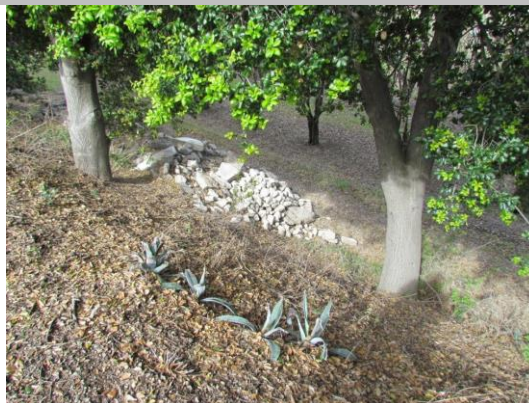
Photo 1 of 2 : SP\_2016\_RD0556\_18\_27\_20160512\_00054.jpg

Unauthorized pile of and concrete placed along the landside within 10-foot of the levee toe.

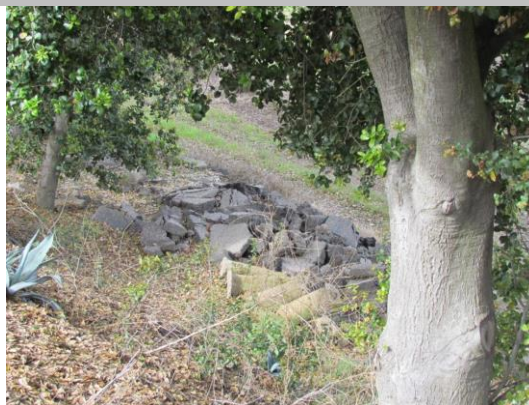
Photo 2 of 2 : SP\_2016\_RD0556\_18\_27\_20160512\_00055.jpg

Unauthorized pile of asphalt and concrete pipe within 10-foot of landward toe.

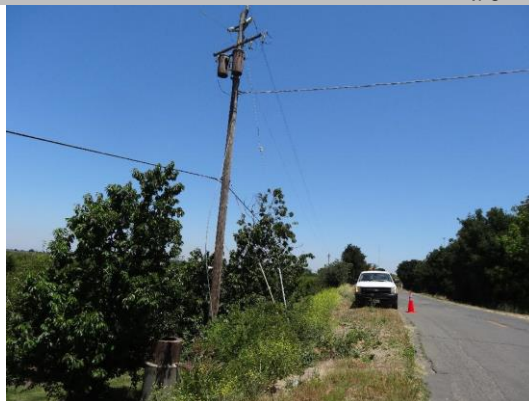
Photo 2 of 2 : UCIP\_SP\_2016\_45743\_74241.jpg

LM Start	1.57	Rating **	M	Issue No.	388 (cont)
LM End	1.57	Issue Type +	En	Location *	WS
Category	Supplemental			GPS Latitude/Longitude	
				Start	End
Item	DWR UCIP Field Study			38.225001 °	38.225001 °
				-121.535007 °	-121.535007 °
DWR ID					
Comment Code					
Inspector Comment					
FS_ID:45743					
DS_ID:20827					
EP_NO: 11169					
Repair Type: Non-Urgent					
Crossing Status: Found					
UCIP Comments: Dense vegetation on LS and WS limited accessibility.					
FIELD_STRUCT_DESC: 8-inch steel pipe through levee, 3.5 feet below crown. Pump and gate valve on WS berm. 2-inch electrical conduit into WS slope. A 36-inch concrete standpipe and concrete block step on Landward Slope. (Listed as 10-inch in ABO 11169 - Mealer). O&M Manual Sac 103, June 1954					
FS Date: 5/27/2015

Service pole next to standpipe off LS toe.

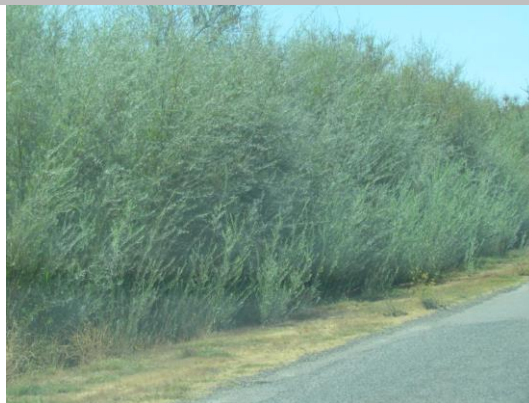
Photo 1 of 1 : SP\_2016\_RD0556\_18\_74\_20160223\_00014.jpg

Levee mile 1.74-2.00 waterside wild growth of arundo present on levee shoulder and slope, unable to see the ground.

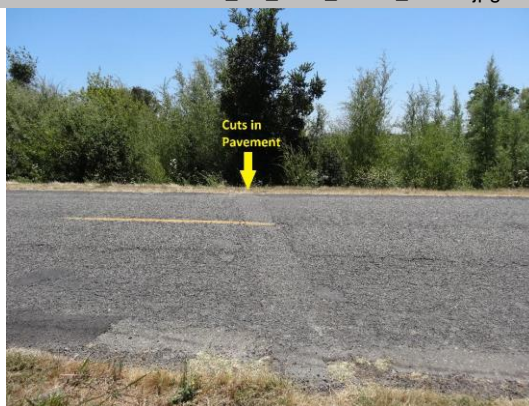
Photo 1 of 2 : UCIP\_SP\_2016\_45746\_74250.jpg

LM Start	1.79	Rating **	M	Issue No.	389
LM End	1.79	Issue Type +	En	Location *	WS
Category	Supplemental			GPS Latitude/Longitude	
				Start	End
Item	DWR UCIP Field Study			38.223999 °	38.223999 °
				-121.538735 °	-121.538735 °
DWR ID					
Comment Code					
Inspector Comment					
FS_ID:45746 DS_ID:20828 EP_NO: 3735 Repair Type: Non-Urgent Crossing Status: Indicator Found UCIP Comments: Dense vegetation on LS and WS limited accessibility. FIELD_STRUCT_DESC: 4-inch electric conduit through levee, 4.0 feet below the crown. Pump on berm. Underground submarine cable crossing. (App. 3735-PG&E). Electric pole on LS in alignment with cuts in pavement. FS Date: 5/27/2015

View of WS and cuts in pavement.

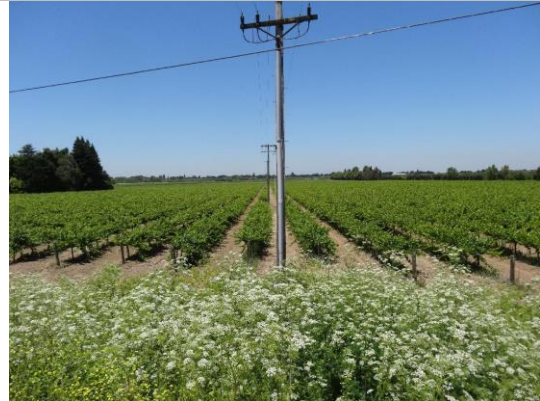
Photo 2 of 2 : UCIP\_SP\_2016\_45746\_74251.jpg

Cuts in pavement in alignment with electric pole off LS toe.

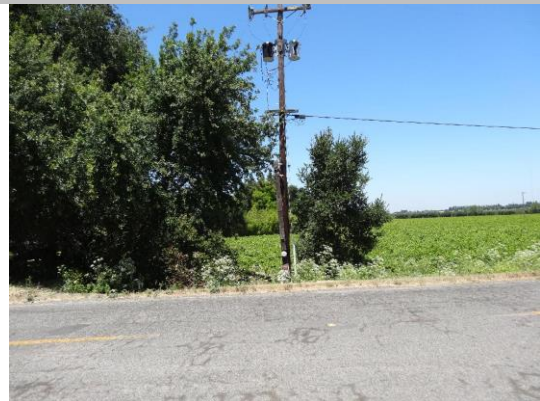
Photo 1 of 2 : UCIP\_SP\_2016\_45764\_74260.jpg

LM Start	1.89	Rating **	M	Issue No.	390
LM End	1.89	Issue Type +	En	Location *	WS
Category	Supplemental			GPS Latitude/Longitude	
				Start	End
Item	DWR UCIP Field Study			38.223760 °	38.223760 °
				-121.540629 °	-121.540629 °
DWR ID					
Comment Code					
Inspector Comment					
FS_ID:45764 DS_ID:20829 EP_NO: 11178 Repair Type: Non-Urgent Crossing Status: Found UCIP Comments: Dense vegetation on WS and LS. Some oil leakage inside pumphouse. FIELD_STRUCT_DESC: 8-inch steel irrigation pipe through levee, 3.7 feet below crown. 2-inch electric conduit through levee next to 8-inch. A 1-inch air valve and pump on berm. Service pole on landward slope. Tin and wood pump house on berm. A 12-ft x 36-inch concrete standpipe on landside. (ABO- 11178 - Swett). O&M Manual Sac 103, June 1954 FS Date: 5/27/2015

LS view: service pole on LW slope. Standpipe not visible in photo.

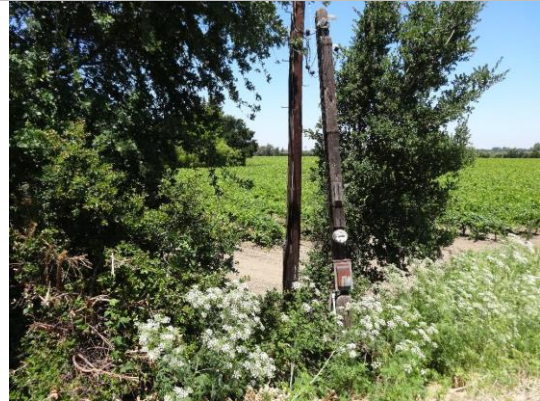
Photo 2 of 2 : UCIP\_SP\_2016\_45764\_74261.jpg

Pole on LS slope with electric box and 2-inch conduit.

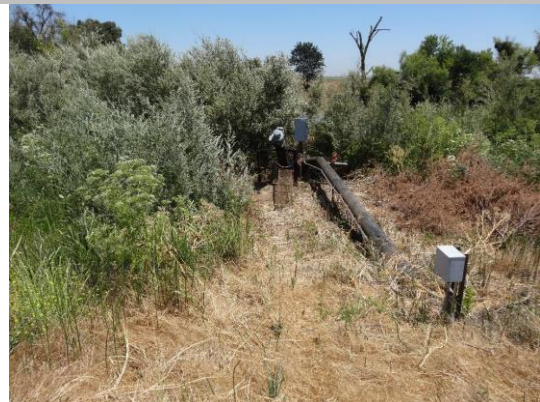
Photo 1 of 2 : UCIP\_SP\_2016\_45786\_74280.jpg

LM Start	2.13	Rating **	M	Issue No.	391
LM End	2.13	Issue Type +	En	Location *	WS
Category	Supplemental			GPS Latitude/Longitude	
				Start	End
Item	DWR UCIP Field Study			38.222560 °	38.222560 °
				-121.544485 °	-121.544485 °
DWR ID					
Comment Code					
Inspector Comment					
FS_ID:45786 DS_ID:20830 EP_NO: 2392 Repair Type: Non-Urgent Crossing Status: Found UCIP Comments: Hole and exposed depression adjacent to pipe at LS. Dense vegetation on WS and LS limited visibility. FIELD_STRUCT_DESC: 12 inch steel irrigation pipe through levee, 3.0 feet below crown. Slant pump on bank. 1-inch electrical conduit through levee beside 12-inch pipe, visible on WS. Service pole and 2 standpipes at LW toe, one of which is a 6-inch standpipe. (App. 2392 - Swett) FS Date: 5/27/2015

WS view: Slant pump, 12-inch and 1-inch pipe through levee.

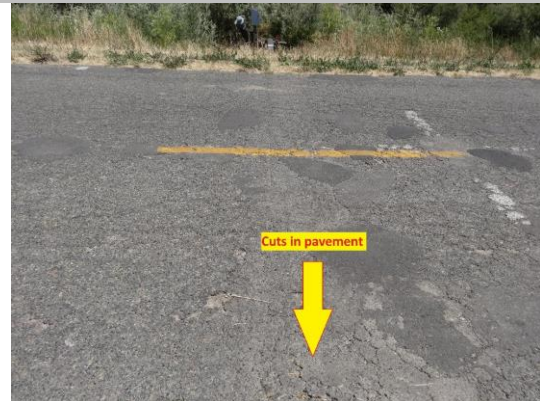
Photo 2 of 2 : UCIP\_SP\_2016\_45786\_74281.jpg

View toward WS with cuts in pavement in alignment with pipe on WS

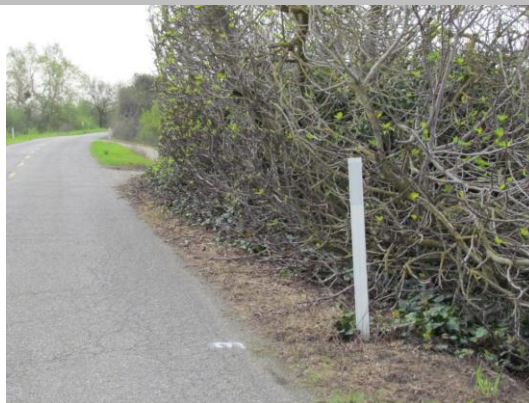
Photo 1 of 1 : SP\_2016\_RD0556\_18\_24\_20160512\_00058.jpg

Looking downstream from levee mile 2.32- 2.34 woody growth of fig trees blocking the view of the levee slope and toe.

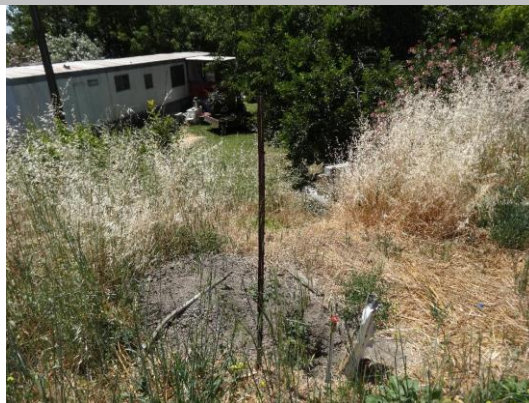
Photo 1 of 2 : UCIP\_SP\_2016\_45803\_74285.jpg

LM Start	2.44	Rating **	U	Issue No.	392
LM End	2.44	Issue Type +	En	Location *	LS
Category	Supplemental			GPS Latitude/Longitude	
				Start	End
Item	DWR UCIP Field Study			38.218242 °	38.218242 °
				-121.543807 °	-121.543807 °
DWR ID					
Comment Code					
Inspector Comment					
FS_ID:45803 DS_ID:20831 EP_NO: 11169 Repair Type: Urgent Crossing Status: Found UCIP Comments: 2'x2' hole on levee off LS shoulder. FIELD_STRUCT_DESC: 8 inch steel irrigation pipe through levee, 3.7 feet below crown. Pump and switch panel on berm. Service pole on landward side. A 9 ft x 36-inch concrete standpipe on landside of the levee. 3 cables encased in 1.5-inch steel pipe at WS alongside 8-inch pipe, disconnected at WS. (ABO 11169-Mealer). O&M Manual Sac 103, June 1954. FS Date: 5/27/2015

Pipe, pump @LS toe. 2'x2' hole off shoulder. Spigot in hole possibly for irrigation. House and service pole in background.

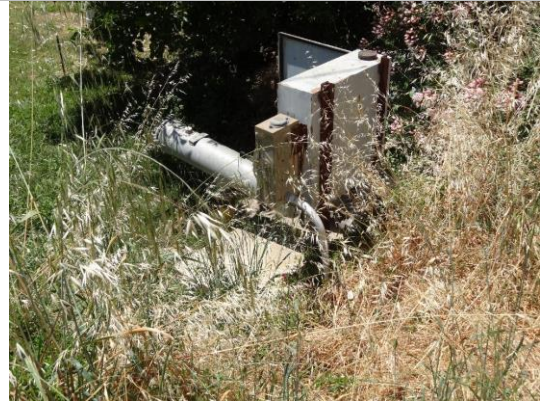
Photo 2 of 2 : UCIP\_SP\_2016\_45803\_74286.jpg

Closeup of 8-inch pipe, electrical conduit and box at LS berm.

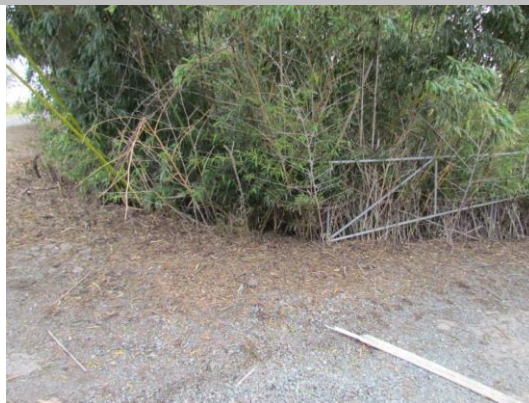
Photo 1 of 1 : SP\_2016\_RD0556\_18\_11\_20160512\_00066.jpg

Looking at levee mile 2.73 unwanted wild growth of arundo covering the landside shoulder and slope.

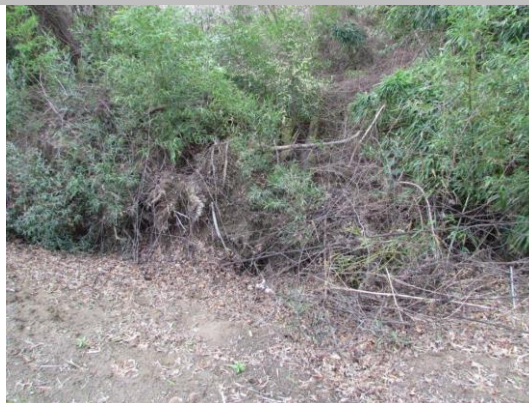
Photo 1 of 1 : SP\_2016\_RD0556\_18\_26\_20160512\_00067.jpg

Looking at levee mile 2.74 landside there is a large fallen tree that is laying on the levee slope from the shoulder down to the toe.

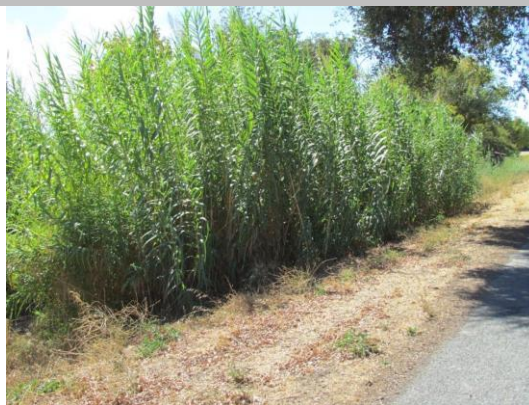
Photo 1 of 1 : SP\_2016\_RD0556\_18\_78\_20160223\_00015.jpg

Looking downstream from waterside shoulder, arundo blocking view of levee section.

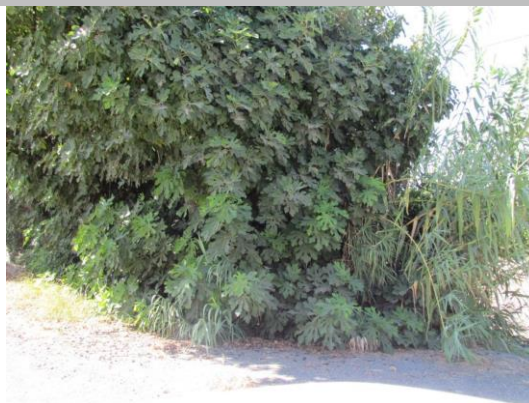
Photo 1 of 1 : SP\_2016\_RD0556\_18\_79\_20160223\_00016.jpg

Unsatisfactory woody tree growth and arundo blocking view of landside levee shoulder and slope.

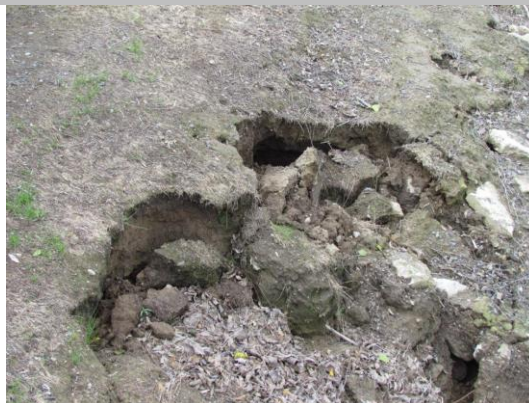
Photo 1 of 1 : SP\_2016\_RD0556\_18\_46\_20160512\_00065.jpg

Looking from levee mile 3.24 landside slope. Erosion has occurred from gopher holes in slope.

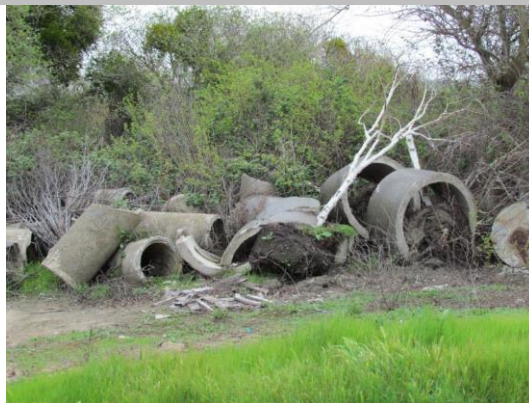
Photo 1 of 1 : SP\_2016\_RD0556\_18\_23\_20160512\_00062.jpg

Looking downstream of levee mile 3.46 discarded concrete pipe and plant containers on the waterside shoulder.

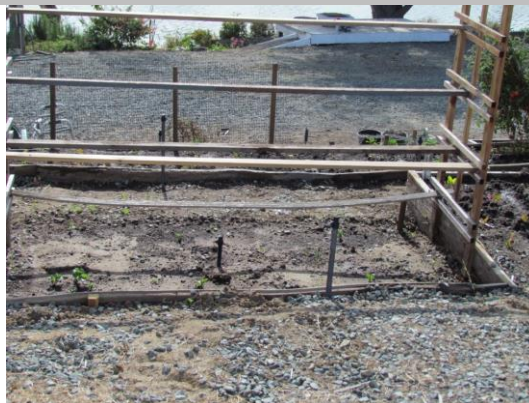
Photo 1 of 2 : SP\_2016\_RD0556\_18\_70\_20160223\_00010.jpg

Landowner has dug into waterward slope and placed planterboxes.

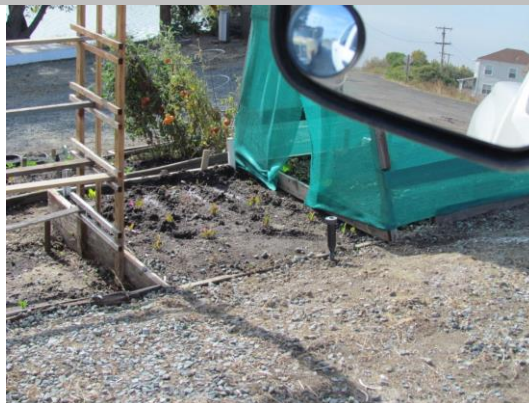
Photo 2 of 2 : SP\_2016\_RD0556\_18\_70\_20160223\_00011.jpg

Continue placement of unauthorized planter boxes into levee slope waterside.

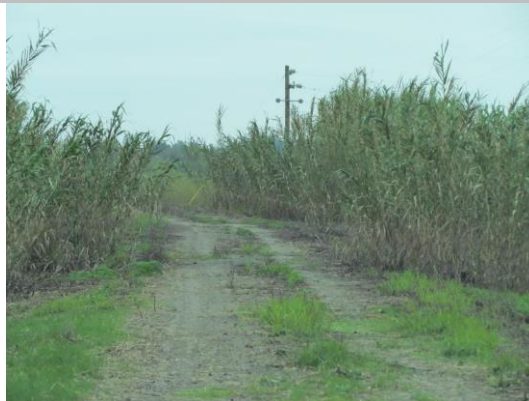
Photo 1 of 1 : SP\_2016\_RD0556\_18\_66\_20160512\_00064.jpg

Looking downstream from the landside shoulder and slope levee mile 4.07-5.47 arundo completely blocking the view of the levee section.

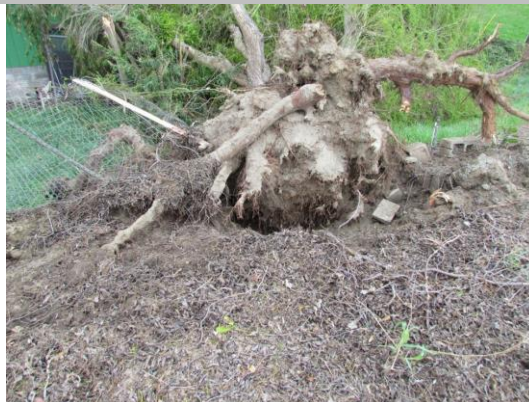
Photo 1 of 2 : SP\_2016\_RD0556\_18\_54\_20160512\_00059.jpg

Standing at levee mile 5.45 landside fallen tree blown over by storm.  
Erosion has occurred at location. Looking upstream.

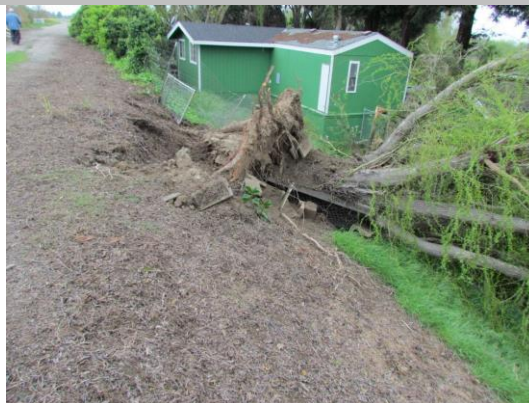
Photo 2 of 2 : SP\_2016\_RD0556\_18\_54\_20160512\_00061.jpg

Standing at levee mile 5.45 looking downstream at fallen tree and bank erosion.

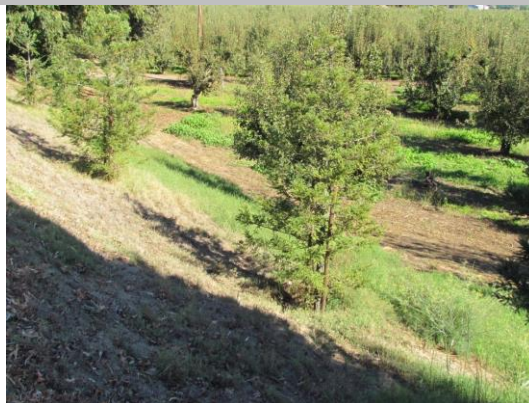
Photo 1 of 1 : SP\_2016\_RD0556\_19\_1\_20160223\_00001.jpg

RD 556 Unit 2 Levee mile 2.28 unauthorized planting of redwood trees planted on the slope.

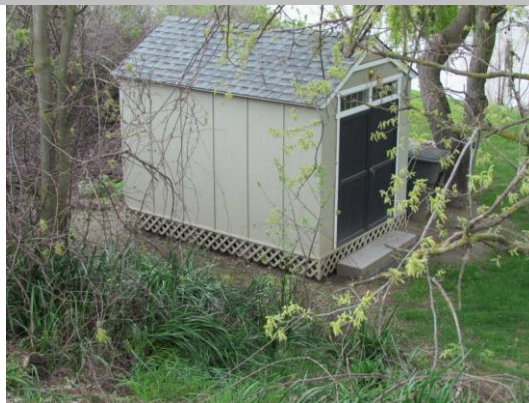
Photo 1 of 1 : SP\_2016\_RD0556\_19\_33\_20160512\_00058.jpg

Looking from levee mile 2.35 waterside at building placed on the waterside berm.

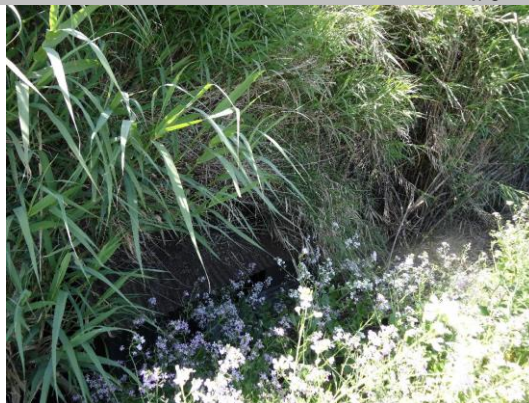
Photo 1 of 2 : UCIP\_SP\_2016\_12545\_20310.jpg

WS- pump house not visible due to the dense vegetation.

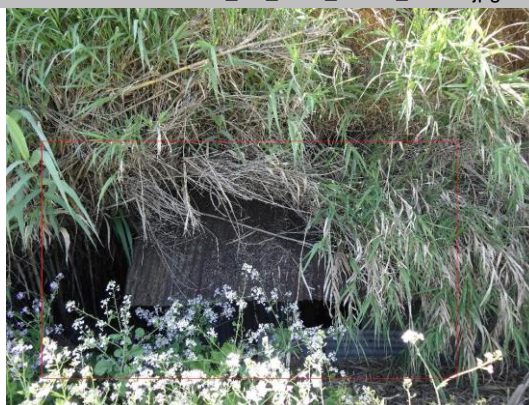
Photo 2 of 2 : UCIP\_SP\_2016\_12545\_20309.jpg

WS- pump house inside the dense vegetation.

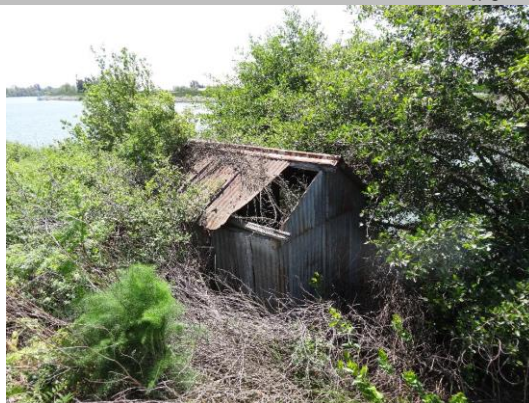
Photo 1 of 2 : UCIP\_SP\_2016\_12546\_20314.jpg

WS- abandoned pump house on levee slope. Dense vegetation on levee slope.

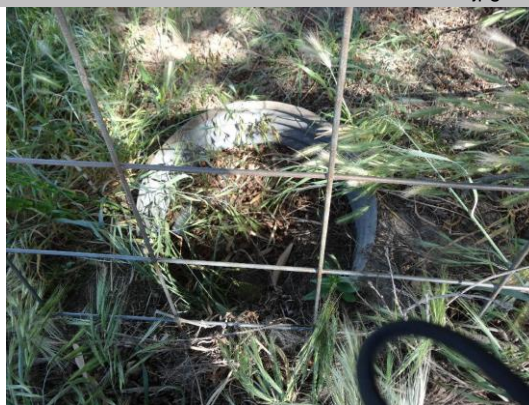
Photo 1 of 2 : UCIP\_SP\_2016\_12547\_20320.jpg

LS- obstructed siphon breaker in CMP riser on levee slope.
